Manhole Inspection Summary

Manhole # S33S__033MH

Inspection ☐ Is Incomplete Rating: **5) Immediate Attention Required**

Insp Date: **8/15/08 11:29 AM**

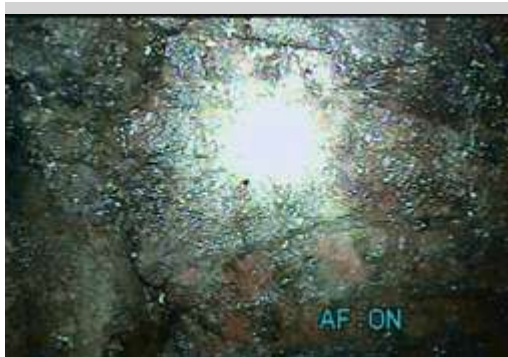
Defect 6

Infiltration: ☐ None ☐ Joint ☐ Cracks ☒ **Mortar** ☐ Roots ☒ **Wall**

infiltration in barrel

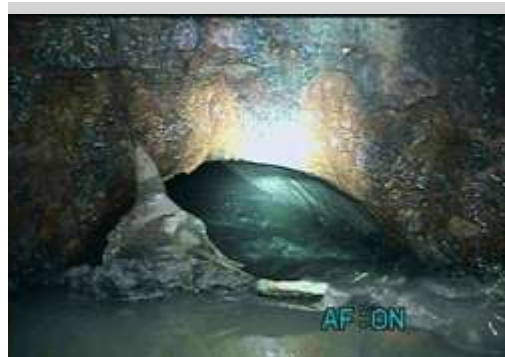
Defect 8

Condition: ☐ Sound ☐ Cracked ☐ Root Intrusion ☐ Deteriorated ☐ Leaks ☒ **Debris**

Channel & Bench Debris

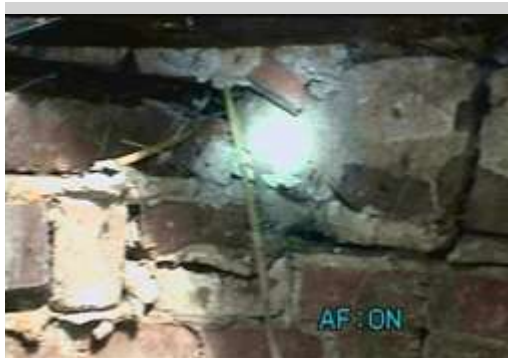
Defect 5

Condition: ☐ Sound ☐ Cracked ☐ Root Intrusion ☒ **Loose Brick** ☐ Deteriorated

barrell loose bricks and cracked

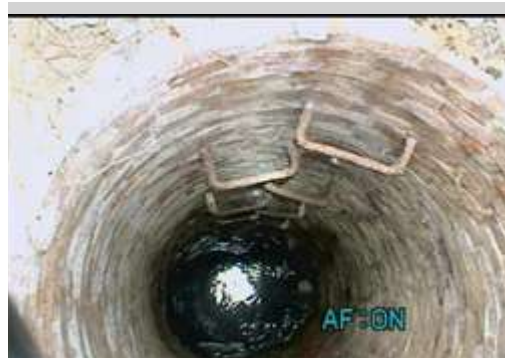
Defect 4

Steps Count: **12** Missing: **0** ☒ **Corroded**

steps

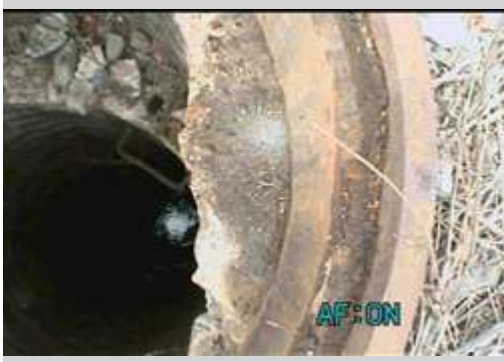
Defect 3

Frame Offset: **4** (in.) Condition: ☒ Sound ☐ Cracked ☐ Leaks

offset

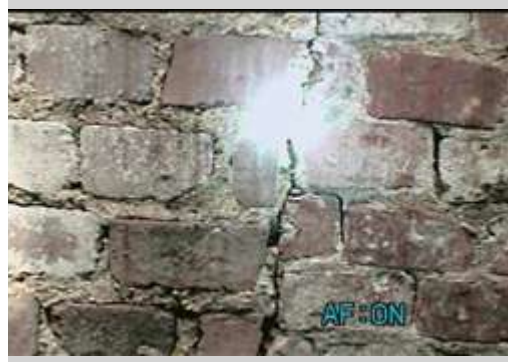
Defect 2

crack in corbel

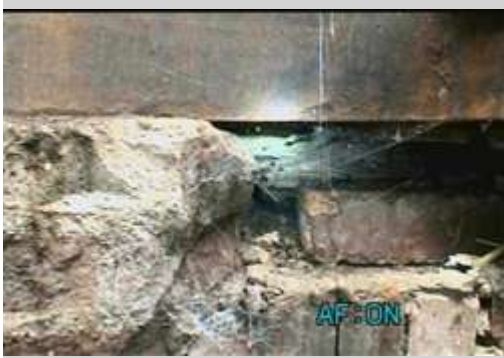
Defect 1

Condition: ☐ Sound ☒ **Cracked** ☐ Root Intrusion ☒ **Loose Brick** ☒ **Deteriorated**

corbel loost bricks and deteriorated

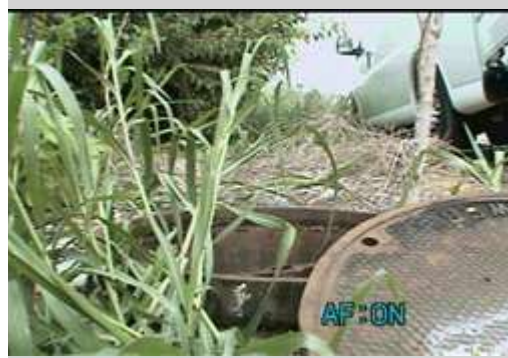
Defect 7

Comments **Missing Grade You can see straight into the manhole with the cover on!**

cover to grade 5"
